# STSM report COST FP1404

# **Post fire investigation of timber elements in a Stockholm building**

Scientific report of STSM at Byggnadstekniska Byrån,  
Stockholm, Sweden

## The Royal Institute of Art

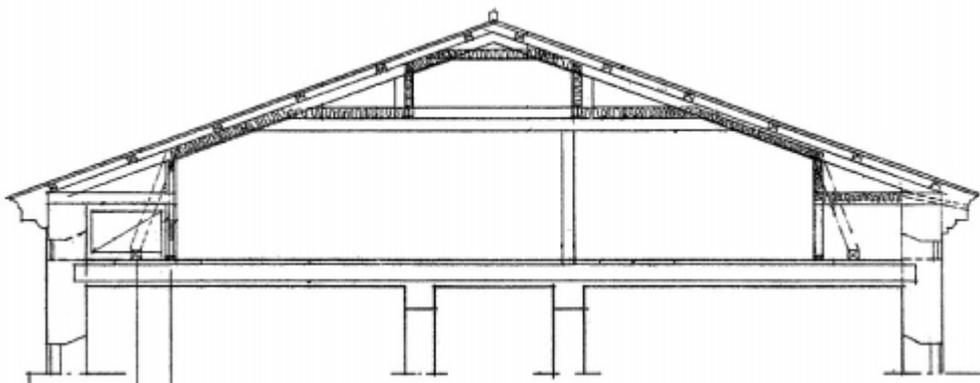
The building consists of six floors including basement and wind. Roof top with wooden roof consists of sheet metal, plywood, insulation, PVC foil, plaster, wood and beams. Internal steel piles hold up the roof structure together with interior walls. The outer walls consist of bricks and tiled facade. Parts of the interior. The walls of the wind consist of easy-to-handle construction of wood, plaster and insulation. The wind beam consists of wooden beams, bricks, 2 layers of wood floors / boards and lime gravel. See Figure 1. (Royal Building Agency, 1987)[1][2]

Figure 1: Roof Structure [1]

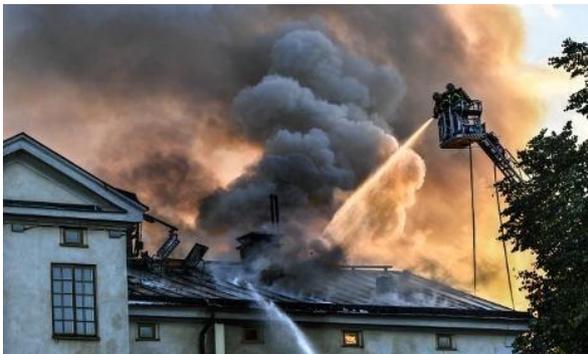
*Figure 2- Extinguishing the attic fire [3]*

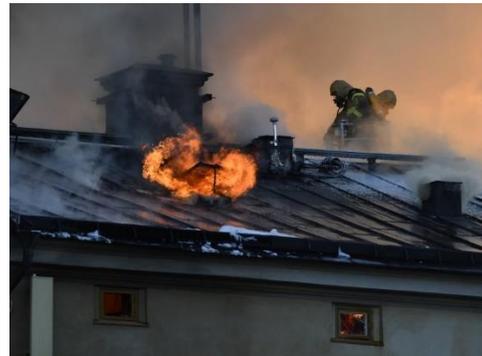
*Figure 3 – Extinguishing from the roof [4]*
